# Report

Accident on 6 August 2014  
**at Saint-Jean-les-Deux-Jumeaux (77)**  
**to the Socata TBM700**  
registered N129AG

**BEA**

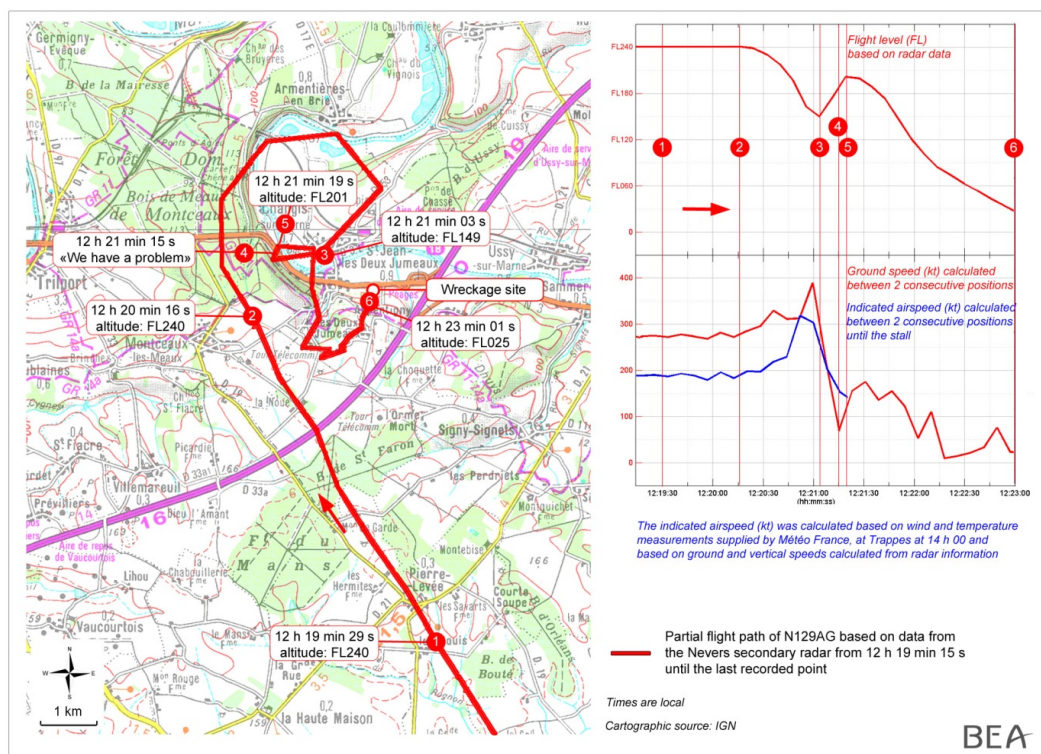
Figure 1 : flight path

A 12 h 20 min 16 (point 2 on the flight path below)<sup>(2)</sup>, while the aeroplane was about 25 NM to the east of Paris in IMC with a ground speed of about 270 kt (that's to say an indicated speed of around 190 kt), it swerved to the right and started to descend to flight level FL149. The average vertical speed during this descent was about 11,500 ft/min and the ground speed reached 390 kt (that's to say an indicated speed of around 300 kt).

At 12 h 21 min 03 (point 3), the aeroplane was still in IMC and started to climb again.

At 12 h 21 min 09, the pilot, in response to a call from ATC, transmitted a brief incomprehensible radio message on the Paris ATC frequency. At 12 h 21 min 15 (point 4), the pilot told ATC "We have a problem", then the aeroplane reached FL201 (point 5). The ground speed reached about 100 kt. The aeroplane then started to descend again, with an average vertical speed of more than 10,000 ft/min.

Witnesses saw the aeroplane come out of the clouds between 1,000 and 2,000 ft from the ground. The aeroplane was in a flat spin, turning anti-clockwise (to the left). It collided with the ground at 12 h 23, with a virtually vertical flight path, flat (point 6).

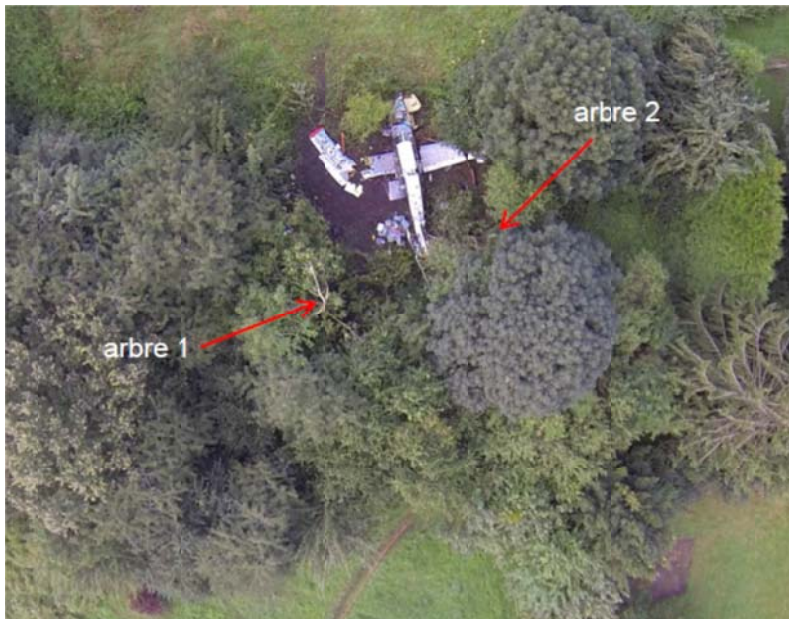
Figure 2 : aerial view of the accident site, with positions of the damaged trees

The trees that were around the wreckage were about a dozen metres high. There was little damage to the vegetation. A tree was cut off at the left rear of the aircraft, about a dozen metres from the ground, another at right rear of the aircraft, at 7 metres from the ground (see figure 2).

These distortions on the wreckage and the damage to the trees at the accident site showed that the aeroplane collided flat with the ground, along a flight path having an angle of about 30° in relation to the vertical.

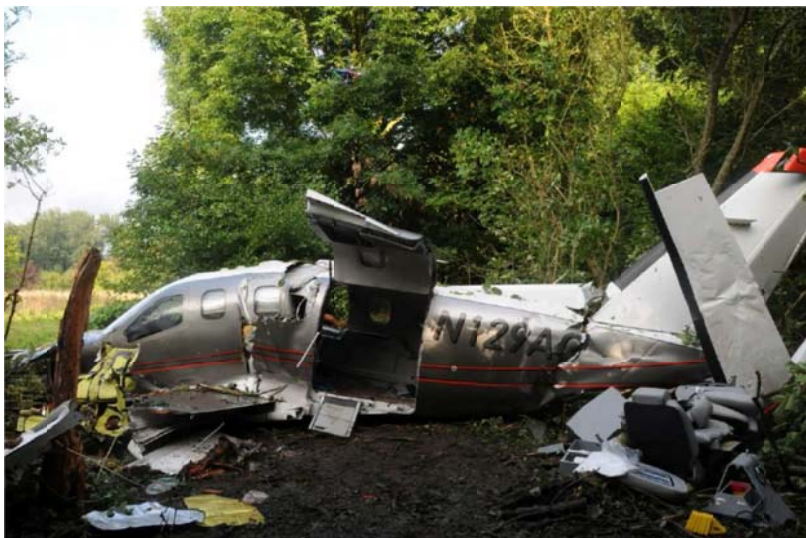
Figure 3 : view of the fuselage, left side

The fuselage was damaged by bending along the longitudinal axis. The main rupture was in front of the main door, a second being more aft, on the tail fin root.

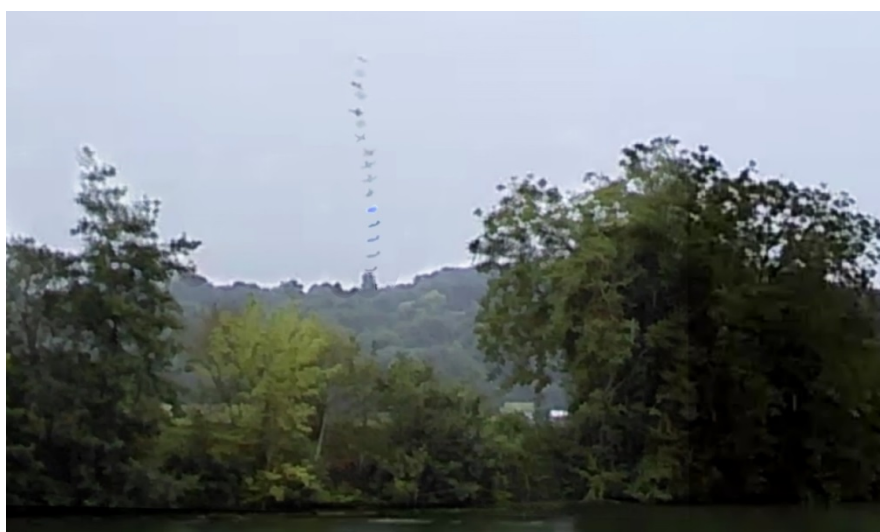
Figure 4 : superimposed video images showing N129AG's flat spin

This picture shows the aeroplane falling in a flat spin, along a virtually vertical flight path. The altitude of the aeroplane on the first video image is about 1,000 ft. The average speed of rotation around the yaw axis during the sequence is about 60 °/s. The vertical speed was about -5 000 ft/min. Analysis of the images on which the aeroplane is seen in profile indicates a left roll angle of the order of 10° and a nose-down attitude of about 10°. On the last images, the roll angle decreased by about 5° and the pitch was between 0° and 5° nose down.

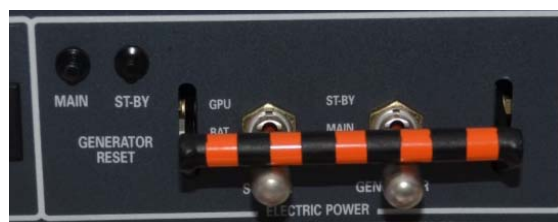
Figure 5 : crash lever

The “crash lever”, which allows the aeroplane’s electrical generation to be cut off, was found in the down position (electrical generation cut off).

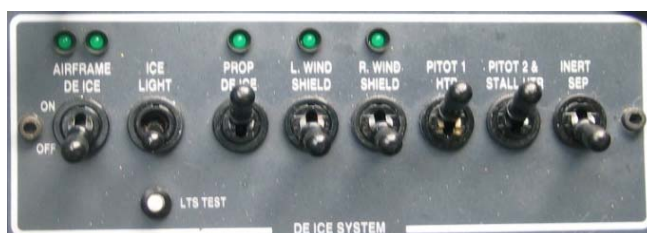
Figure 6 : icing control panel

The control switches for the airframe de-ice system and of the inertial separator<sup>(9)</sup> were found on the OFF position at the site of the accident. However, the propeller de-ice system control switch was found in the ON position<sup>(10)</sup>.

During the climb after the pull-out, the aeroplane was flying at a rapidly-decreasing speed in a cloud layer that posed a risk of severe icing. The pilot had probably not activated the airframe de-ice system. It is not possible to determine if the aeroplane's wings were then contaminated by frost or ice, which would have increased the aeroplane's stall speed. Nevertheless, the high vertical speed of the aeroplane reduced the exposure time in this cloud layer, which makes it unlikely that there was significant ice contamination.
